SERVICE BULLETIN

No. M 6-III/2

Object: Replacement of the connecting rod of MINOR 6-III engine of the production Nos from 33650 to 33899.

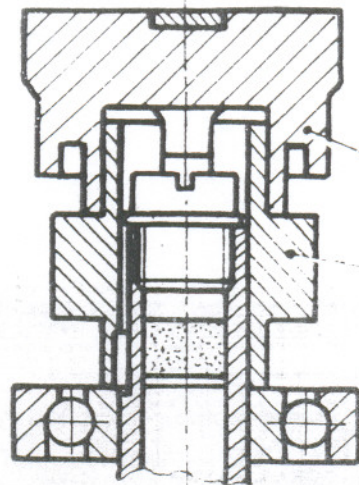
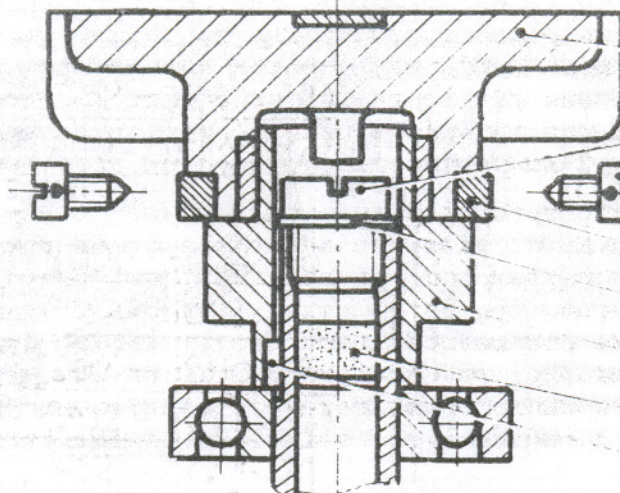
PŮVODNÍ PROVEDENÍ
БЫЛО
PRIMARY DESIGN

NOVÉ PROVEDENÍ
СТАЛО
NEW DESIGN

MEASURE: In order to increase the service life and reliability of operation of the ignition magneto distributor arm, a reconstruction of attachment of the distributor rotor arm onto the contact breaker cam has been carried out. The ignition magnetoes manufactured since 2nd half-year 1975 comprise already the new design of distributor rotor arms and cams, too. The primary (original) design of ignition magnetoes is no more produced, however, it is replaceable with the new design.

If necessary to replace a distributor rotor arm of the primary (original) design with a distributor rotor arm of the new design, in such a case has to be replaced also the contact breaker cam of the primary (original) design with a cam of the new design, as the primary design in comparison with the new design of the contact breaker cam is rather different.
