SERVICE BULLETIN

No. M 6-III/2

Object: Replacement of the connecting rod of MINOR 6-III engine of the production Nos from 33650 to 33899.

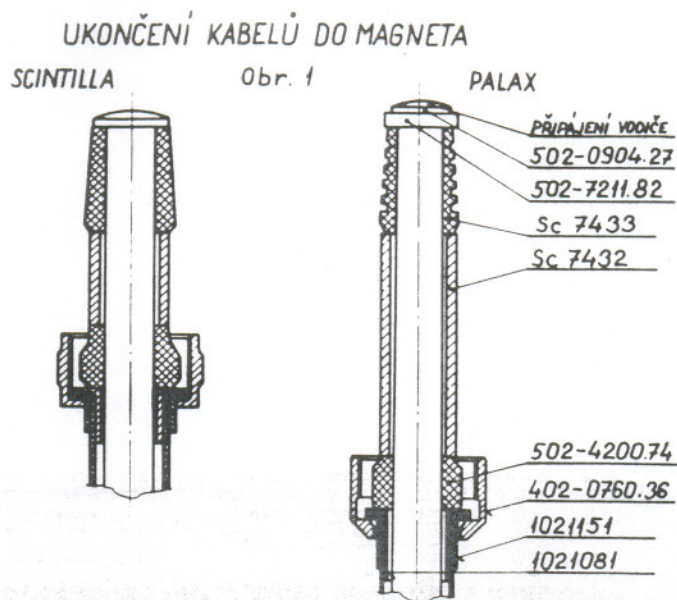
Obr. 2
SCHEMA ZAPALOVÁNÍ MAGNET PALAX
LUN 2221.13

MEASURE: Any defective Scintilla ignition magnetos, each separately or both the magnetos at once, are to be replaced with substantive PAL magnetos.

Fig. 2 - Wiring diagram of PALAX ignition magnetoes, model LUN 2221.13
1 - L.H. side magneto
2 - R.H. side magneto
3 - Accumulator (battery)
4 - Pushbutton switch
5 - Start-signalling buzzer
6 - Change-over switch of ignition magnetoes.

- 1) When replacing a defective Scintilla ignition magneto provided with a break-off coupling, Part No. OBF 6R 701 Z 170 (or the primary design, Part No. OAF 6R 602 Z 170 or AVK 6-Z2) with a PAL ignition magneto, it is necessary to fit additionally a start-signalling buzzer, Part No. LUN 2231, into the ignition circuit of the engine and to replace the starter motor switch pushbutton (see Bulletins Nos. Z 226(126)/25, Z 326/71 and Z 526/42).
- 2) When replacing, however, a defective ignition magneto without any break-off coupling, Part No. OBF 6R 501 Z 170 (or the primary design, Part No. OAF 6R 402 Z 170, or NVK 6-Z2) with a PAL ignition magneto, no start-signalling buzzer is to be fitted in.
